St. Olavs gt. 31

Grundboringer i nr. 31 St. Olavs Gate.

Kristiania, mars 1918

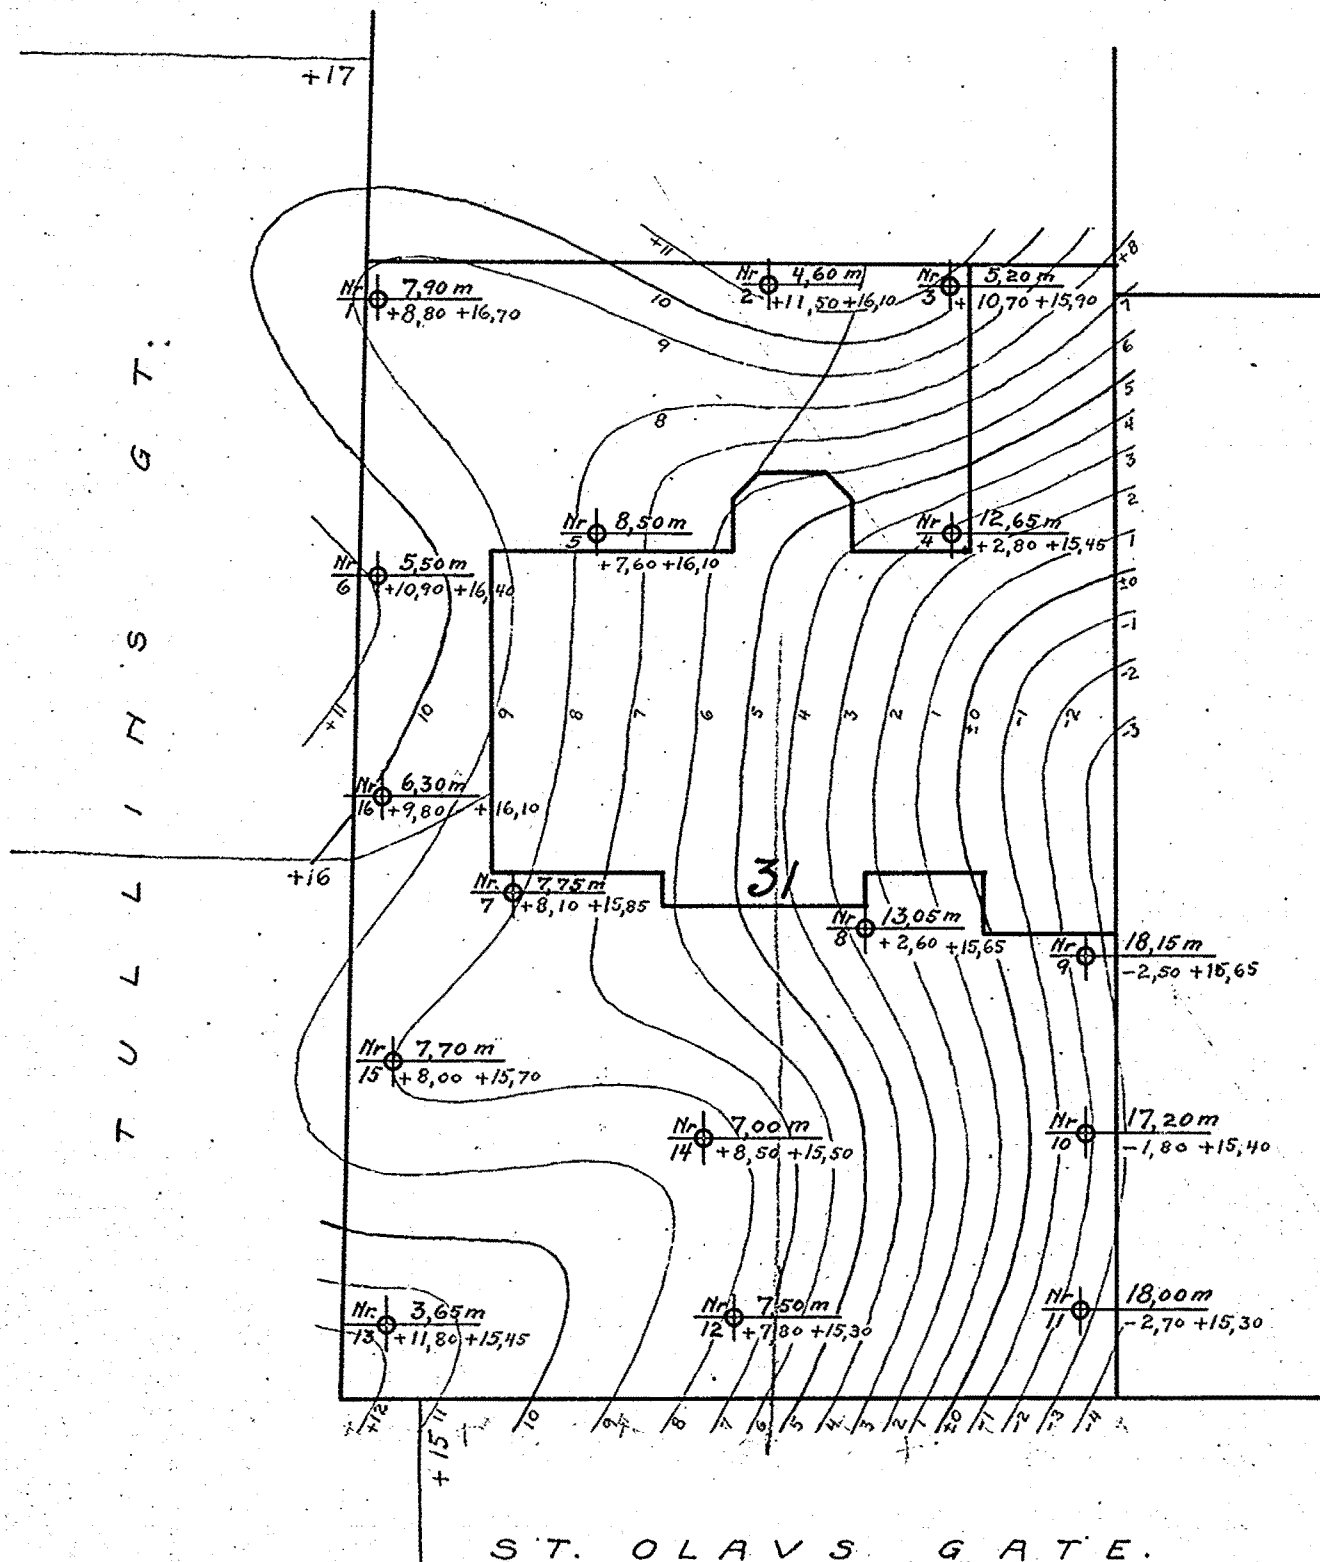
M. 1:250

Brunt betegner terranhøide i forhold til ±0

Blaat --- fjeldhøide " --- " ±0

Sorte tal over streken angir dybde til fjeld.

Hul nr.	m. Fyld.	m. Fast gul (forvit) lere.	m. Fast lere.	m. Blot blaa lere.	m. Blot graa lere.
1	2,00		3,00	2,90	
2	2,00		2,60		
3	2,00		3,20		
4	2,00		3,00	7,65	
5	2,00		3,00	3,50	
6		3,00		2,50	
7	2,00	2,00		3,75	
8	2,00	2,00	1	9,05	
9	2,00		2,00		14,15
10	2,00		2,00	13,20	
11	2,00	2,00		14,00	
12	1,00		3,00	3,50	
13	0,65		3,00		
14	1,00	3,00		3,00	
15	1,00	3,00		3,70	
16	1,00	3,00		2,30

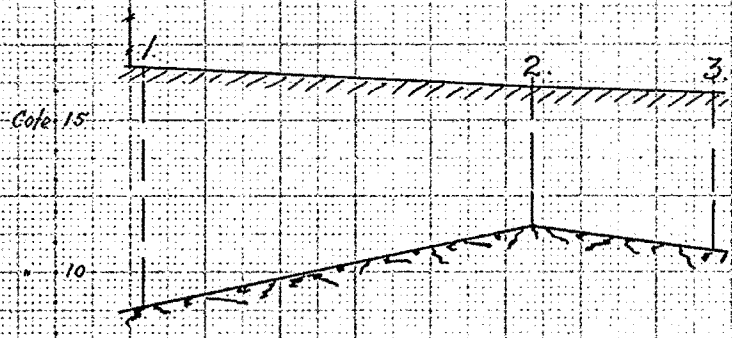
Cote 15 Profil efter borhuller 1-2-3

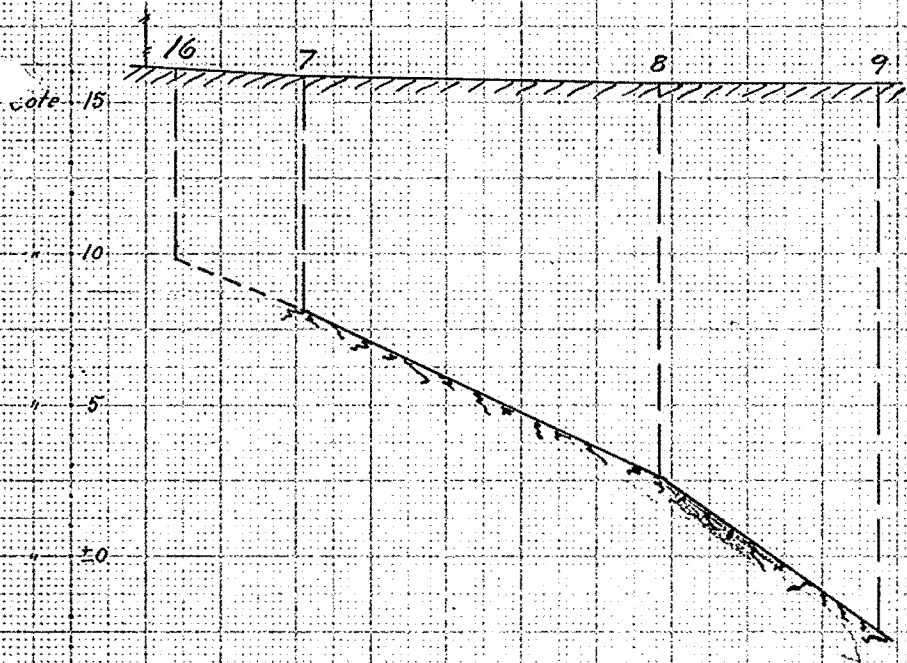
Profil efter borhuller 16-7-8-9

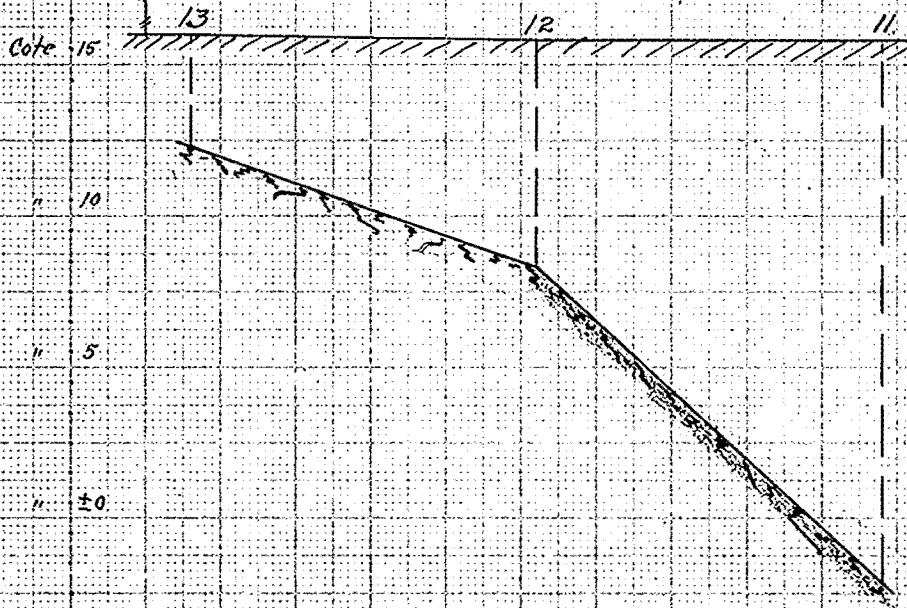
Profil efter borhuller 13-12-11
